**SUBJECT: START 3, EPA Region 8, Contract No. EP-W-05-050, TDD No. 1008-13
Trip Report, Upper Animas Mining District, Silverton, San Juan County, Colorado**

TRIP REPORT
Upper Animas Mining District
Silverton, San Juan County, Colorado

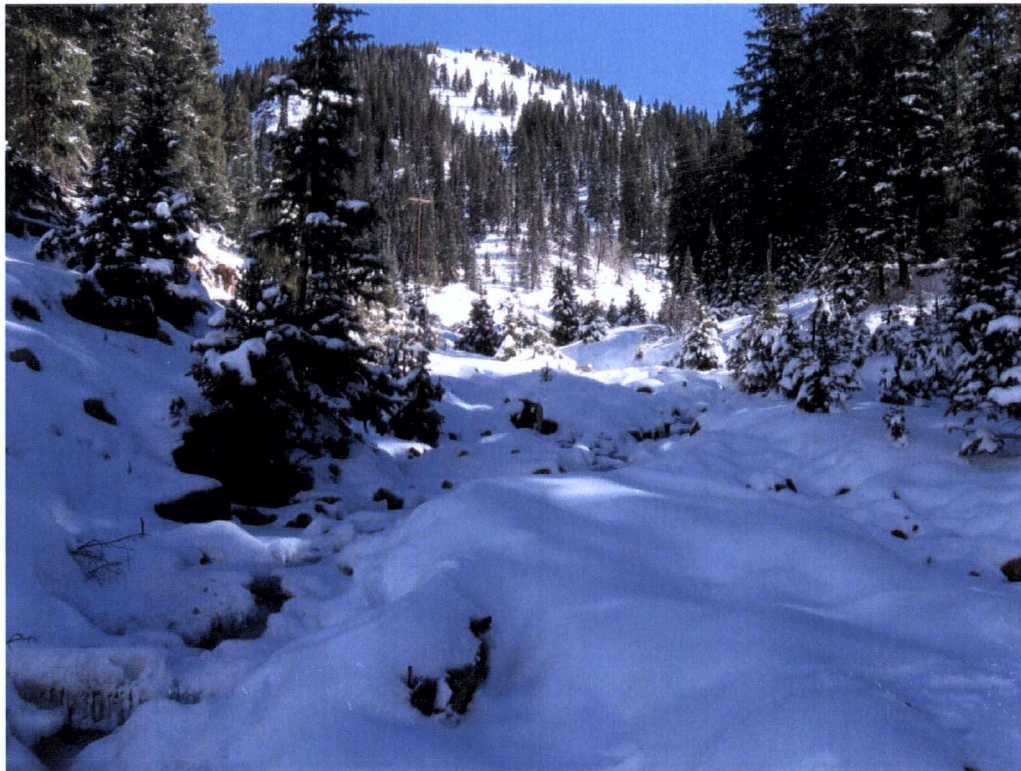
Photo 37
North fork of Cement Creek – flow is low and area is mostly frozen over.

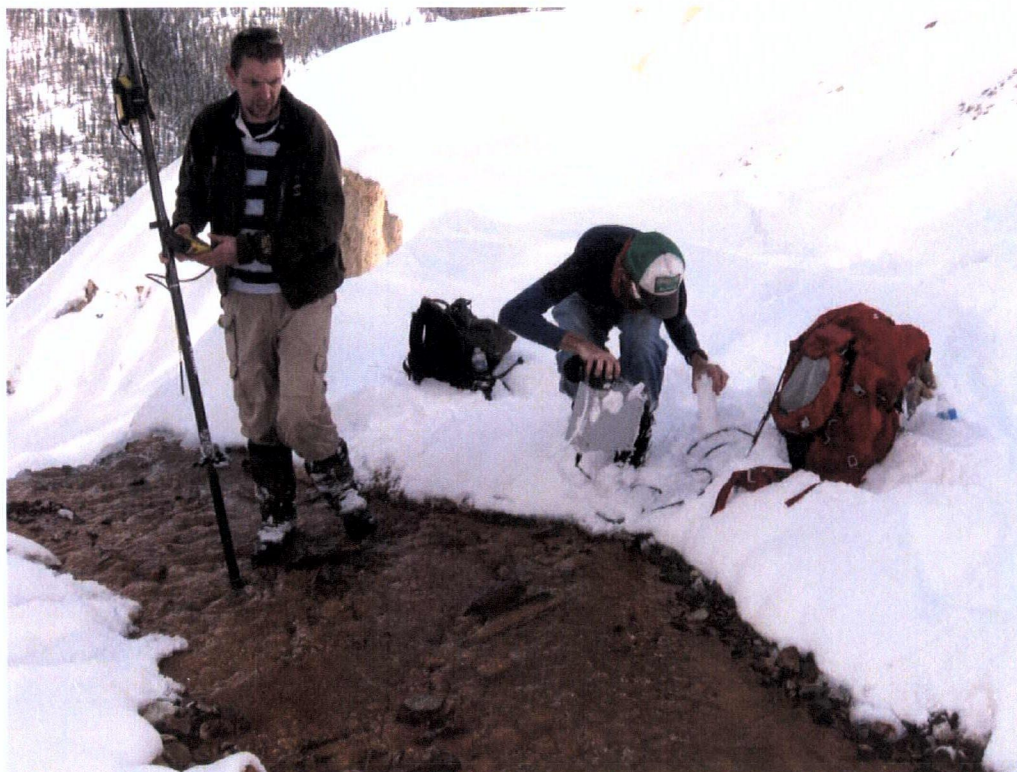
Photo 39

- Samples UASW057 and UASE057 (Dry Gulch discharge) were not collected because START personnel could not identify any flow from Dry Gulch.
- The planned location for samples UASW011 and UASE011 was below all of the Gold King 7 Level waste piles. These samples were instead collected where runoff from the upper piles crosses the mine access road. The planned location could not be safely accessed at the toe of the lower piles due to an extremely steep slope, loose material, and snow.

Collection of UASW011 and UASE011 (north fork of Cement Creek downstream of Gold King 7 Level Mine – at road crossing).

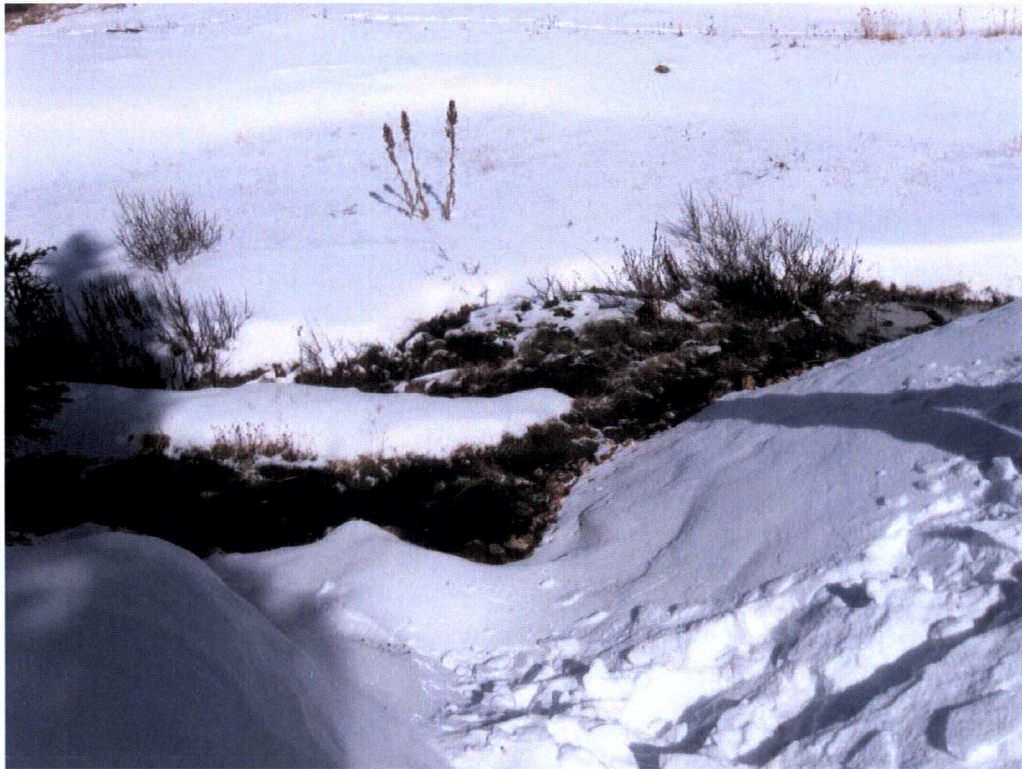
Photo 55
Seepage from the toe of the Mogul North waste pile.

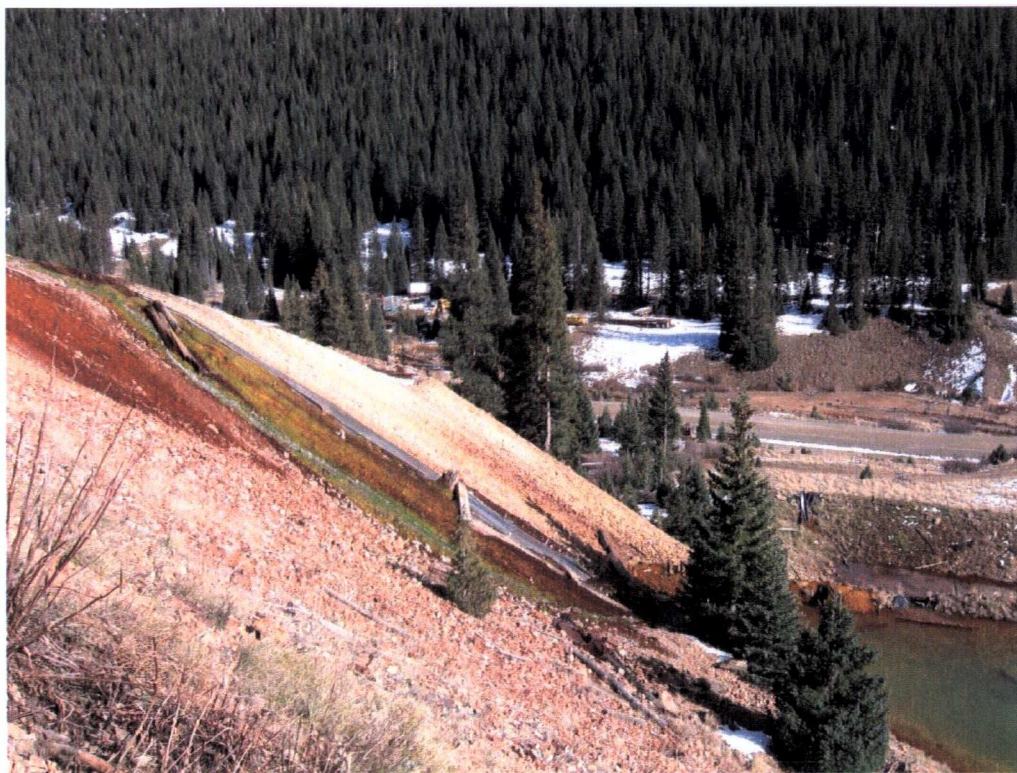
Photo 73
Runoff entering treatment pond in the vicinity of the Mammoth Tunnel.

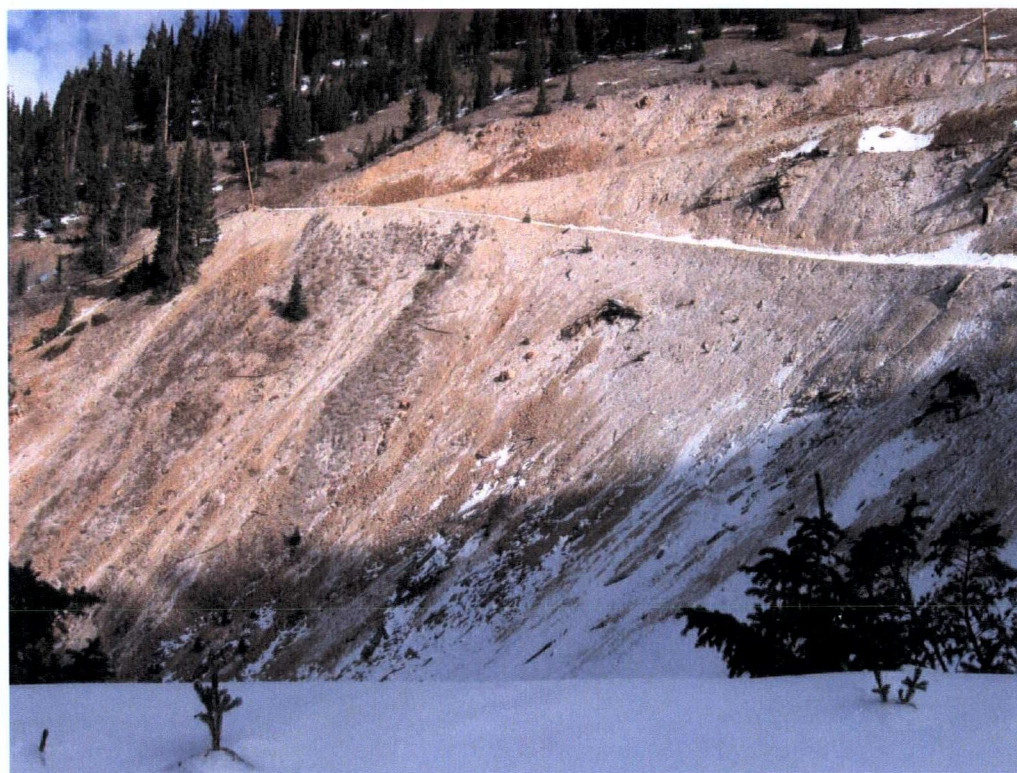
- Soil samples were not collected at the Gold King 7 Level Mine because the waste piles for which START had an access agreement could not be accessed due to unsafe conditions, including extremely steep slope, loose waste rock material, and snow.

Photo 74
Steep slope of Gold King 7 Level waste piles.
